16 - 18 Crown Point Road & 37- 39 Hunslet Road

16 -18 Crown Point Road & 37-39 Hunslet Road, Leeds LS10

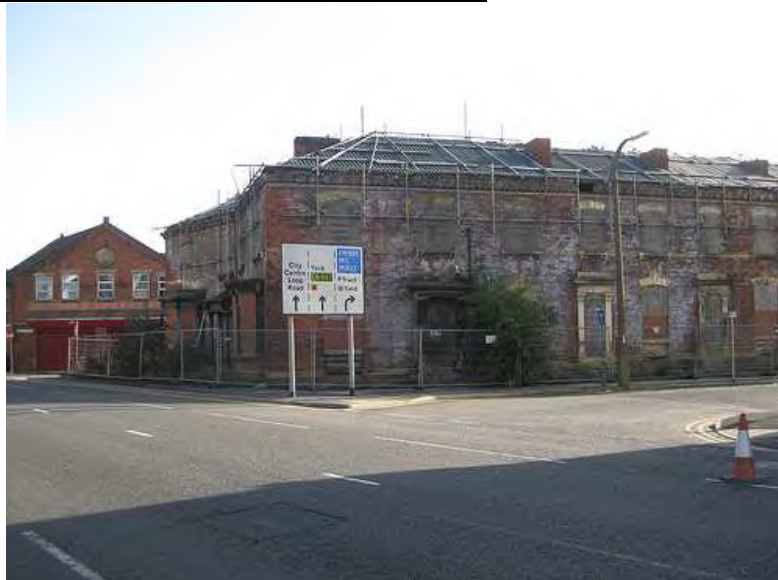
The building is supported by scaffolding and has a temporary roof of metal. All the windows are bricked up which at least makes the building secure. The house shows signs of very heavy water penetration and is covered in growing plants. There are no remaining gutters and great chunks of masonry missing along the roofline. The building has many severe cracks and holes. The soft stone carvings above and below the windows are eroding badly with great loss of detailing. Any remaining wood, e.g. bay windows is rapidly rotting away.
