## Arncliffe

Shire Oak Road, Headingley, LS6

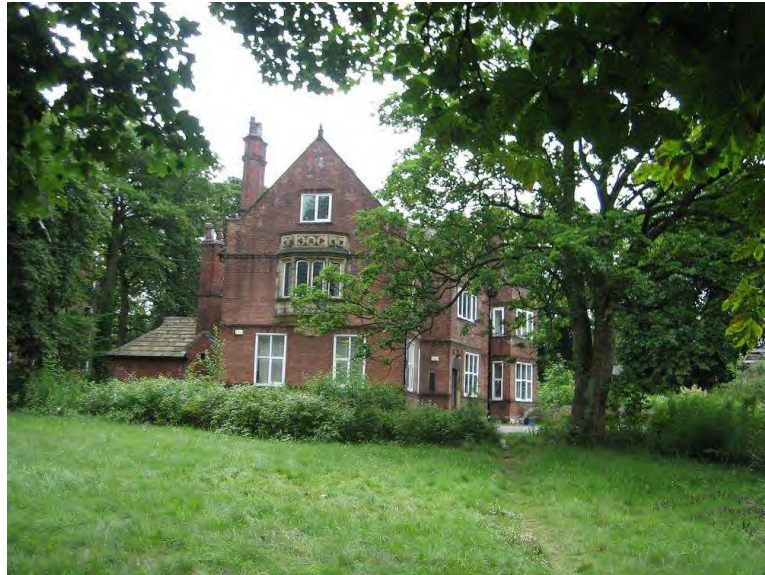
The property is currently let as students flats. There is evidence of a general deterioration to the site since the date of the last survey. The site is overgrown with vegetation in parts, with overflowing dustbins and rubbish strewn about. Some fall pipes are broken, causing damage to brickwork etc. It was not possible to view the interior.
