Hunslet Mill and Victoria Works Complex

Goodman Street, Hunslet, LS10

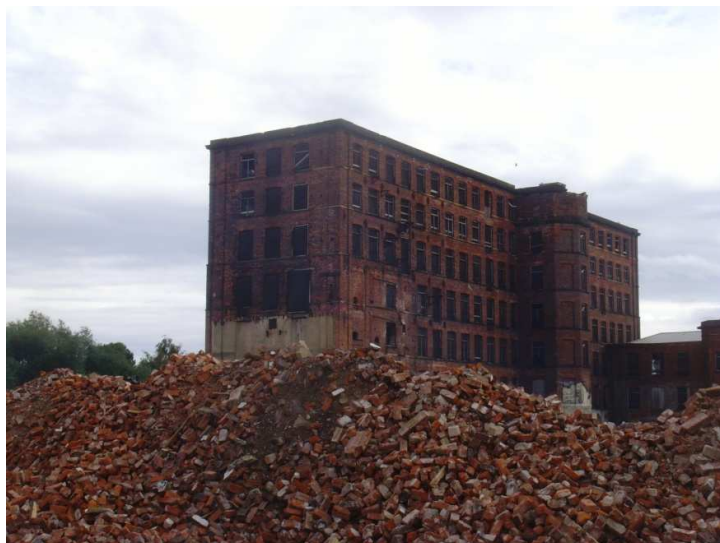
Hunslet Mill is in poor condition, the ground floor windows have been blocked in but the higher floors have only got some black sheeting, which in some areas has come loose and will be allowing water ingress. Some demolition is taking place at present and a new housing development has been built adjacent to the mill so hopefully this will encourage works to progress. **Victoria Works** is also in poor condition with evidence of leaking guttering and boarded up windows. The brick extension and stone entrance to the right hand side is collapsing.
