Scott Hall Farm

Scott Hall Street, Buslingthorpe, LS7

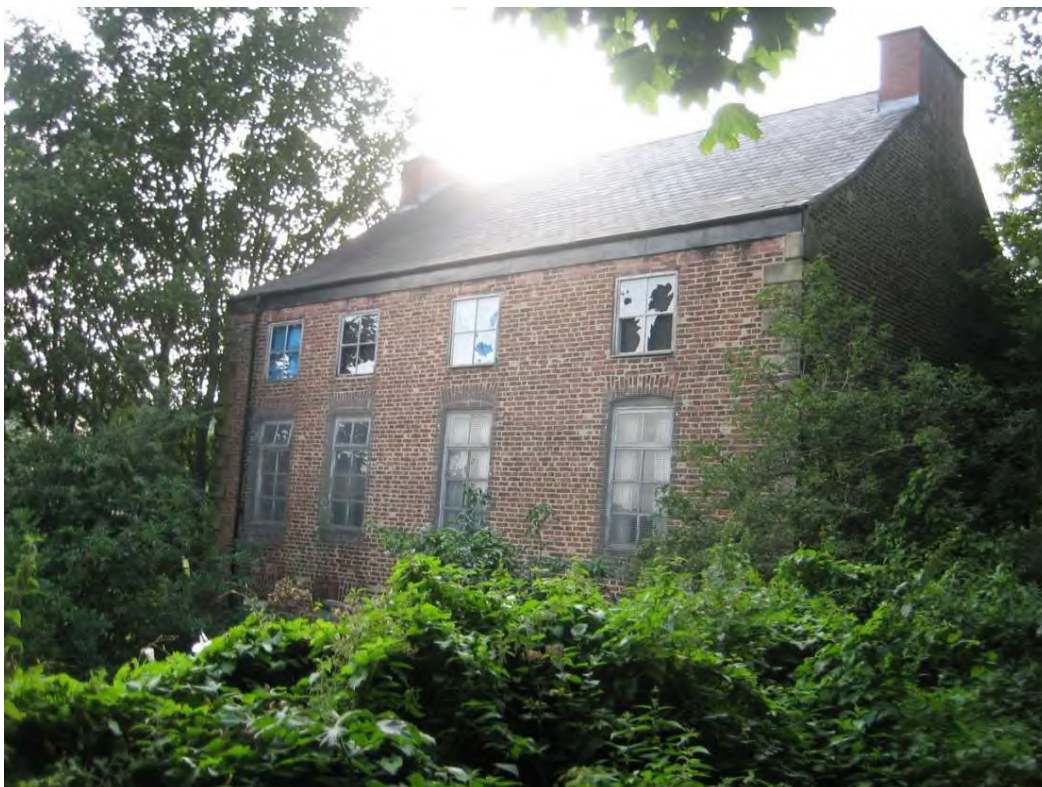
It is constructed with brown hand-made bricks in Flemish and random bonds with rusticated stone quoins and a slate swept roof. It is a 3 storey building with 4 unevenly-spaced windows with segmental brick arches and top-hinged casements. The central entrance has been altered and the eaves and stacks rebuilt. The original fenestration to the rear includes tall round-arched stair window. The right return was built against a steep slope with terraced routeway at 1st-floor level, there is a blocked loading doorway right with the pegged wooden casing exposed.

The building is inaccessible with warnings of security systems in place i.e. guard dogs. It is currently on the market together with a large amount of land, outhouses and garages. The estate agent's information pack describes the building as a 'derelict detached hall' that has 'suffered years of neglect and some fire damage'. All openings are boarded up and the whole site is overgrown. Nevertheless, the building retains an imposing and attractive frontage.
